Living with the West Florida shore

Larry J. Doyle, Dinesh C. Sharma, Albert C. Hine,
Orrin H. Pilkey, Jr., William J. Neal, Orrin H. Pilkey, Sr.,
David Martin, and Daniel F. Belknap

Duke University Press Durham, North Carolina 1984
Property of CSC Library

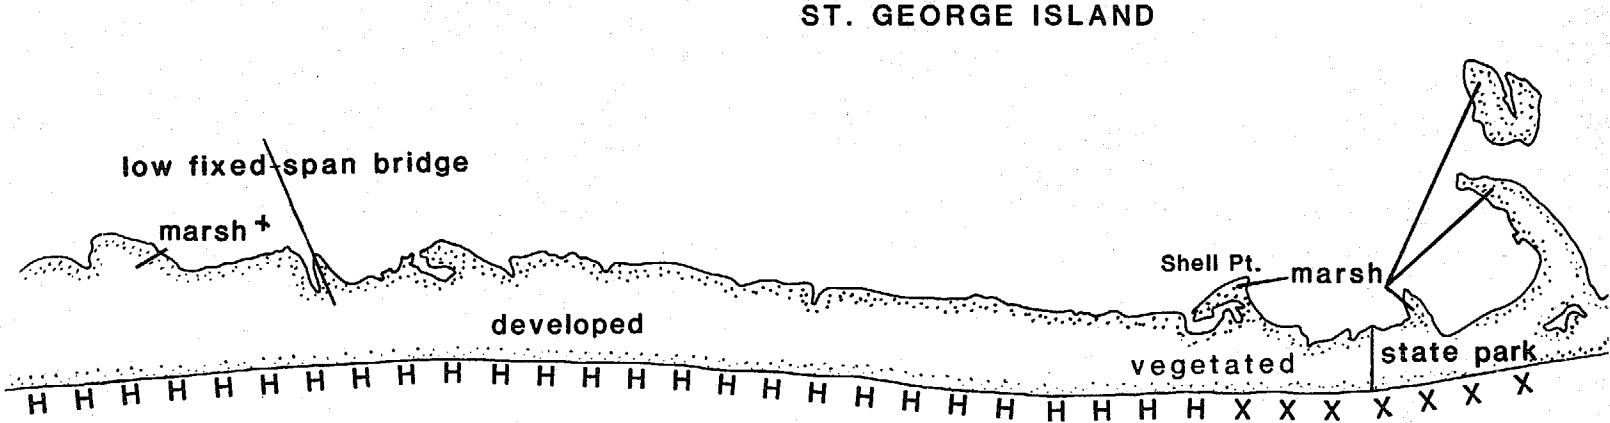
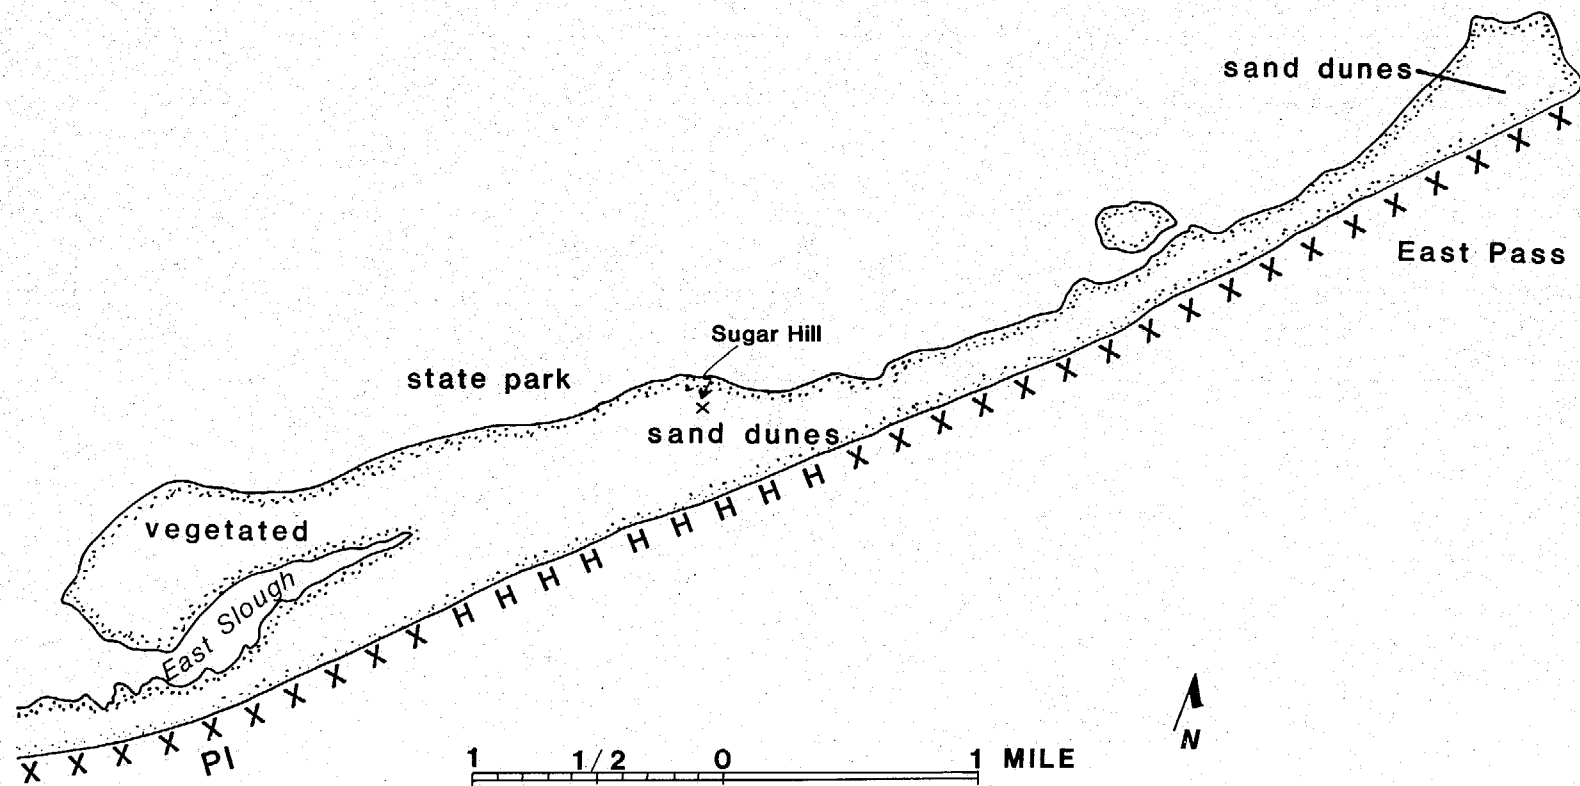
Fig. 5.24. Site analysis map: eastern half of St. George Island.

300'-400' erosion
during previous 70-80 yrs.

St. George Island's (figs. 5.23 and 5.24) eastern end built out-

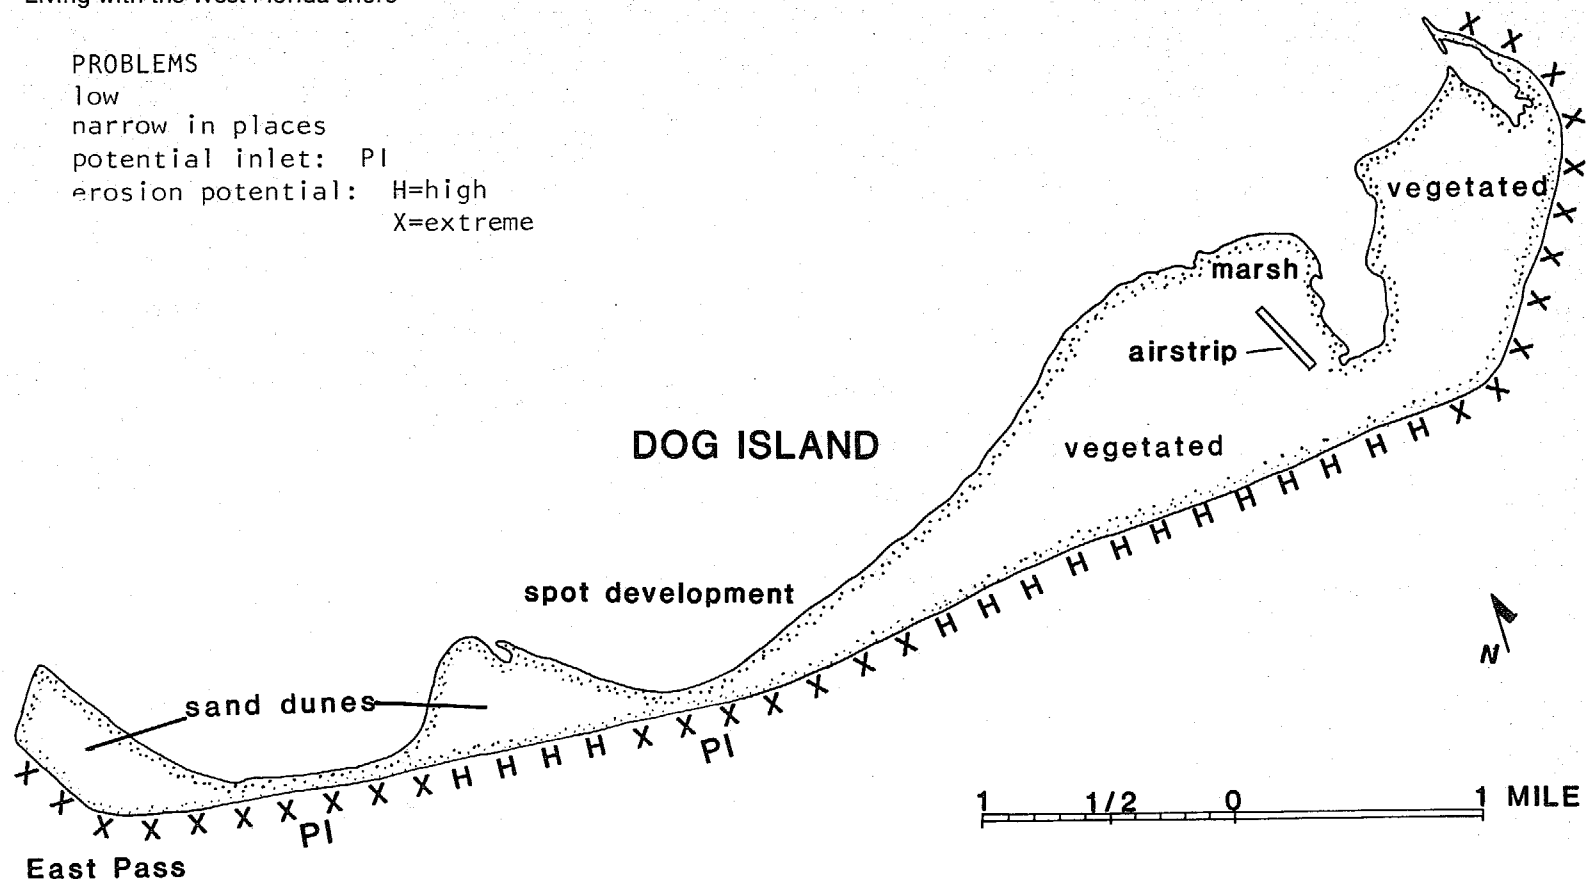
Fig. 5.25. Site analysis map: Dog Island.

Dog Island (fig. 5.25) has undergone constant landward migration of the shoreline for all except the east and west ends where it is building outward. The beaches are rather narrow, and the offshore Gulf profile is moderately steep. Three-quarters of the island is protected by dunes averaging 8 to 23 feet in height. Dog Island is an excellent example of curving dune-and-swale topography in a relatively undisturbed state. The highest dunes are more than 35 feet. The western areas of the island have been subject to frequent overwash during minor storms because of their low topography. A 3-mile section fronting the Gulf that has been developed with homes is undergoing erosion, and steep scarps are appearing on the dunes. The west end of Dog Island has advanced about 1 mile between 1855 and 1935.

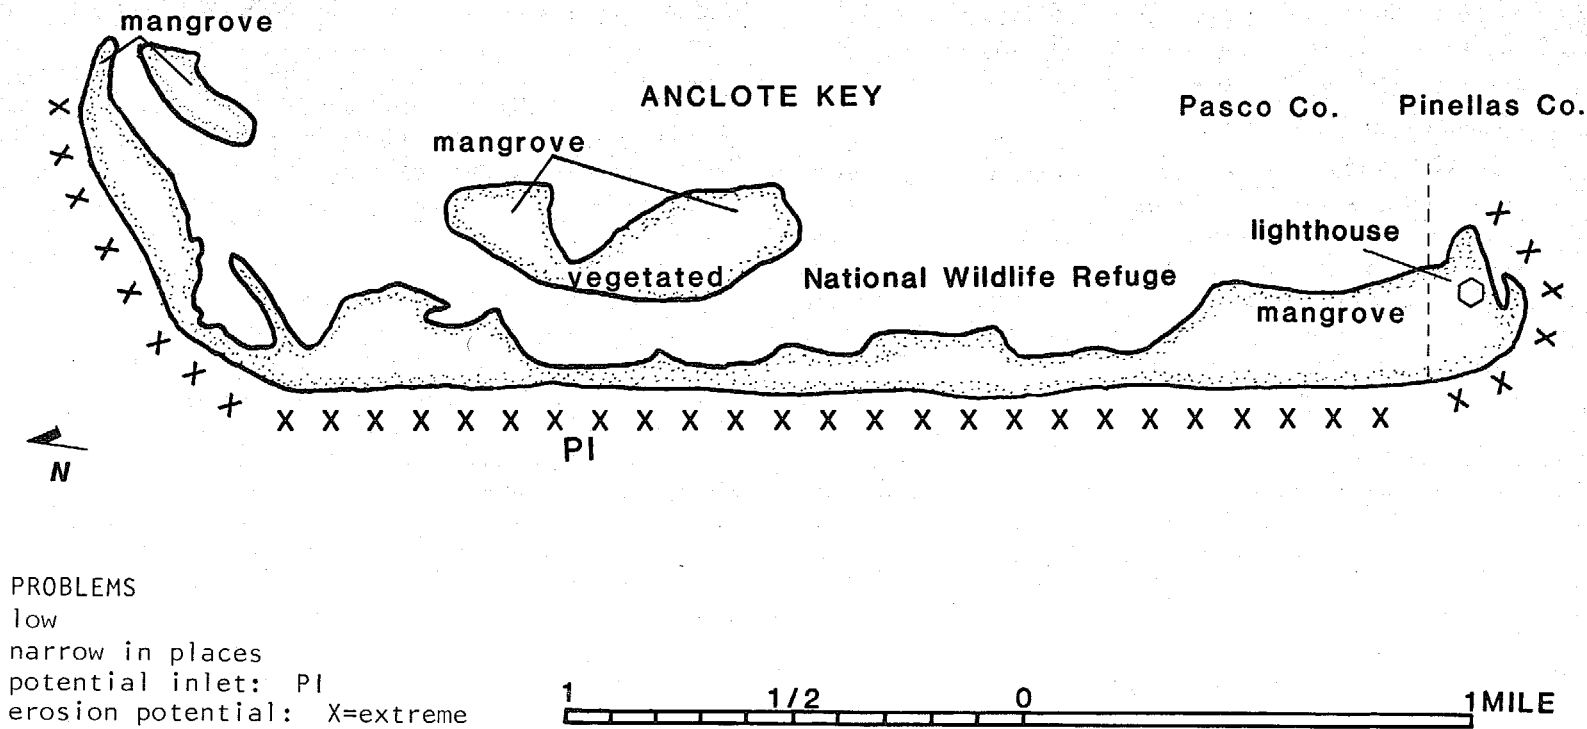
Fig. 5.27. Site analysis maps: Ancolote Key and Honeymoon Island.

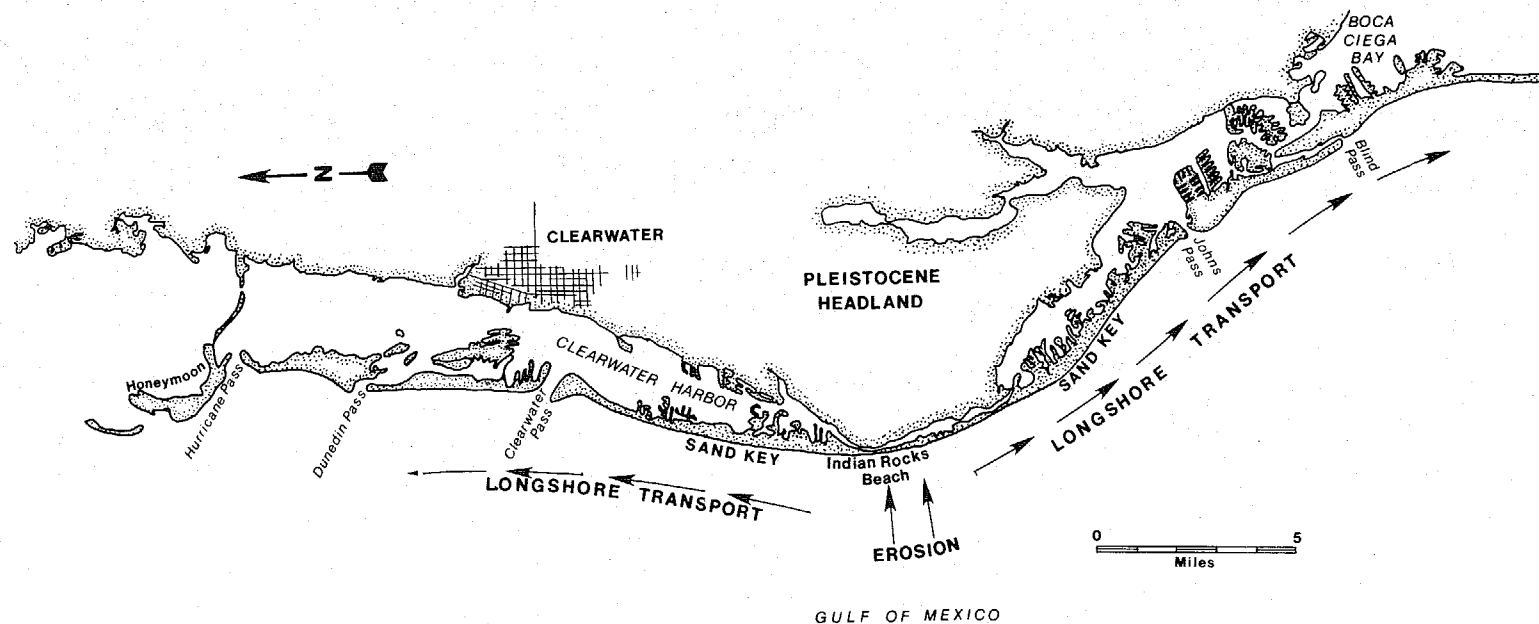
Fig. 5.28. Erosion at Indian Rocks Beach furnished sand that is carried to the islands both north and south.

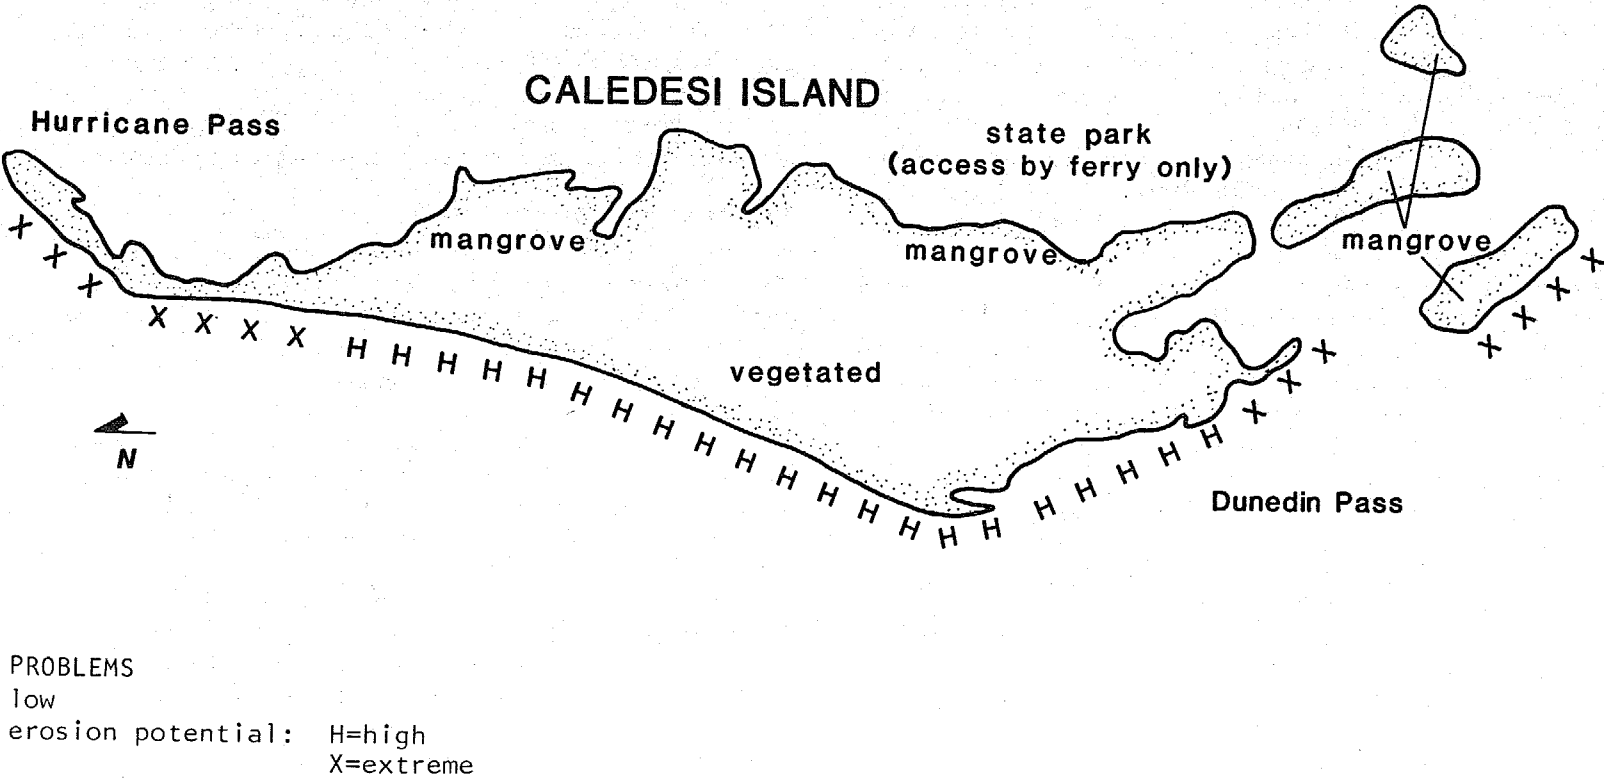
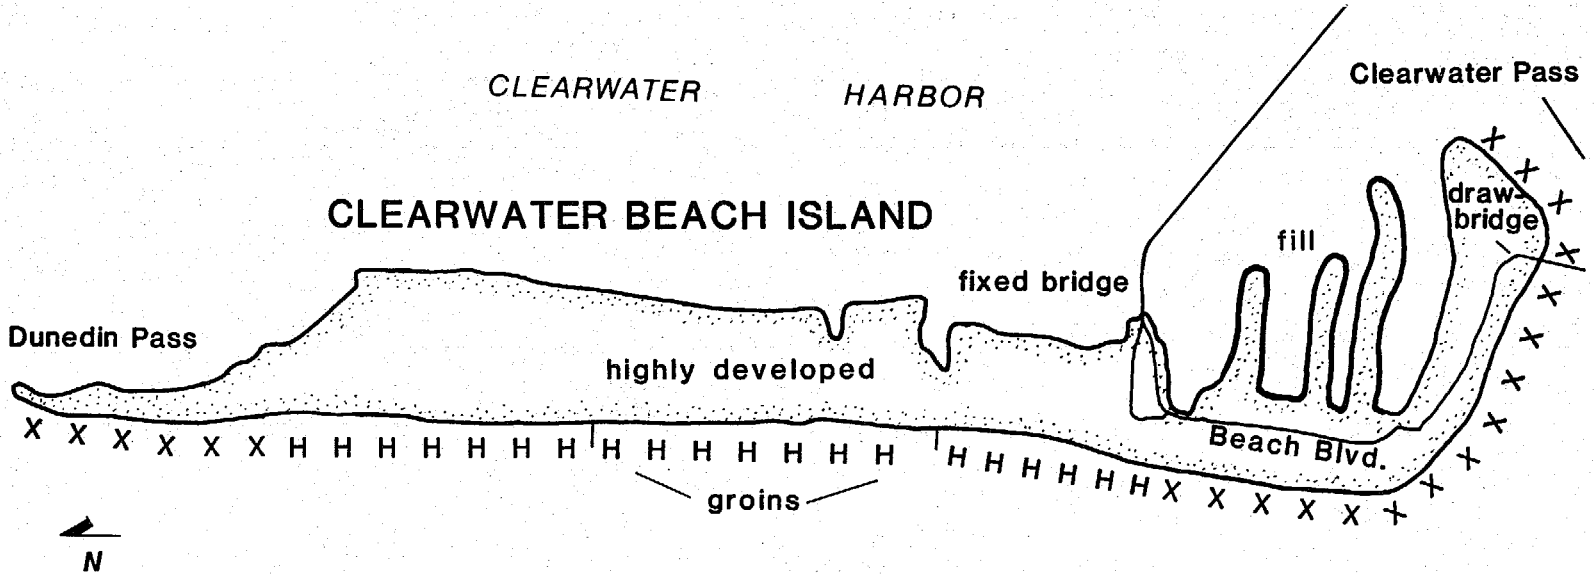
Fig. 5.29. Site analysis map: Caledesi Island and Clearwater Beach Island.

PROBLEMS
 evacuation difficult
 low
 artificially stabilized
 erosion potential: H=high
 X=extreme

Dunedin Pass separates Caledesi Island from Clearwater Beach Island to the south (fig. 5.29). Clearwater Beach is followed in turn by Clearwater Pass, Sand Key, John's Pass (fig. 5.30), Treasure Island, Blind Pass, and Long Key (fig. 5.31). With the exception of the northern end of Sand Key, which is moderately developed, these barrier islands are intensively developed with single-family dwellings, hotels, motels, and high-rise condominiums. The back sides have been extended into Clearwater and Boca Ciega bays by extensive dredge, fill, and finger canal construction. Tens of thousands of people live and vacation here.

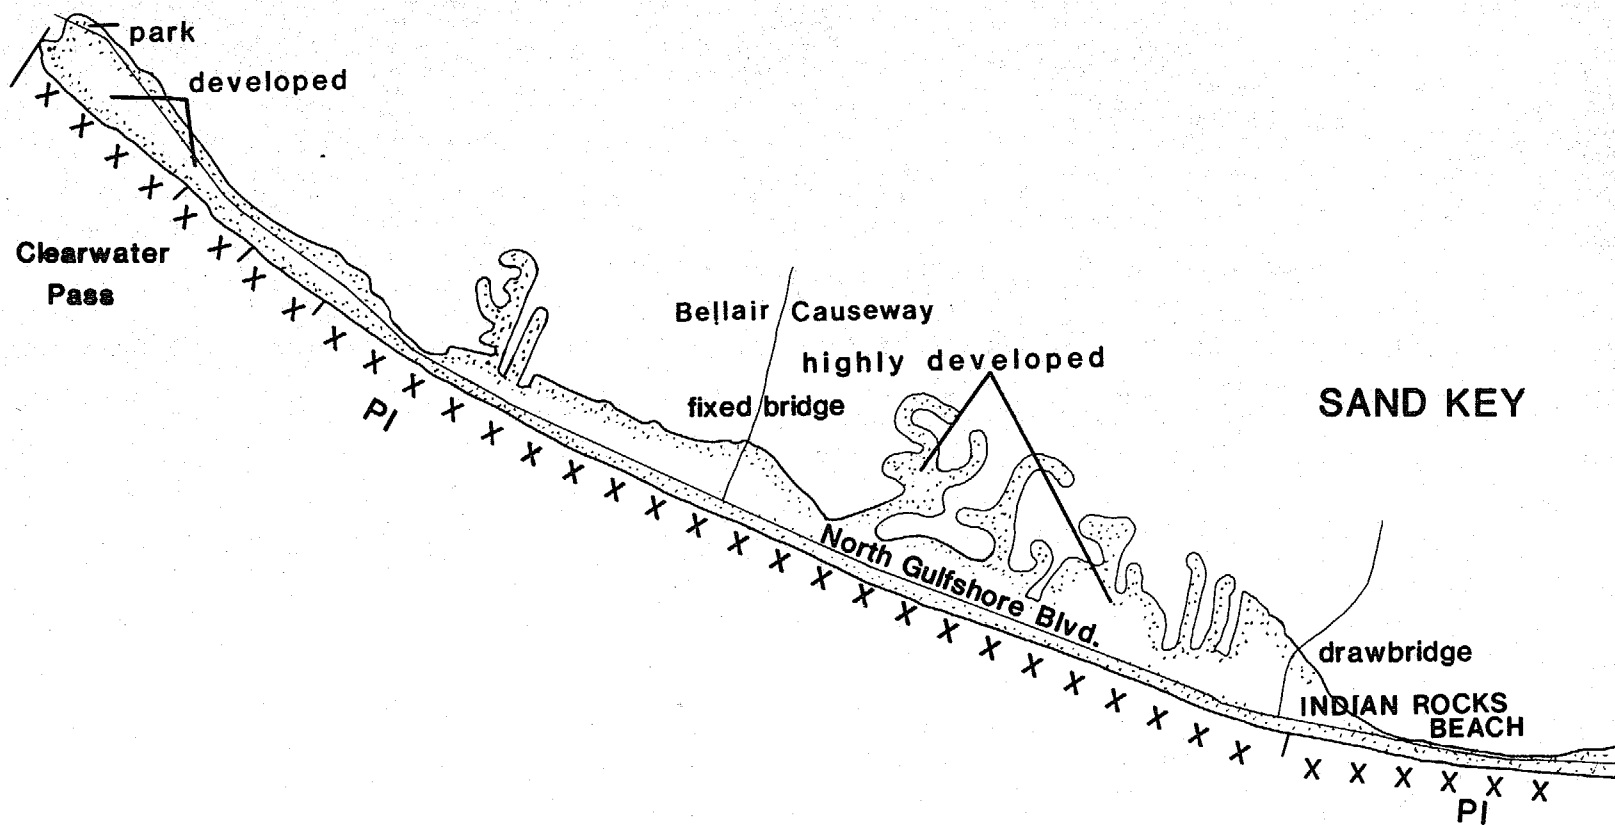
Fig. 5.30. Site analysis map: Sand Key, Clearwater Pass, through John's Pass.

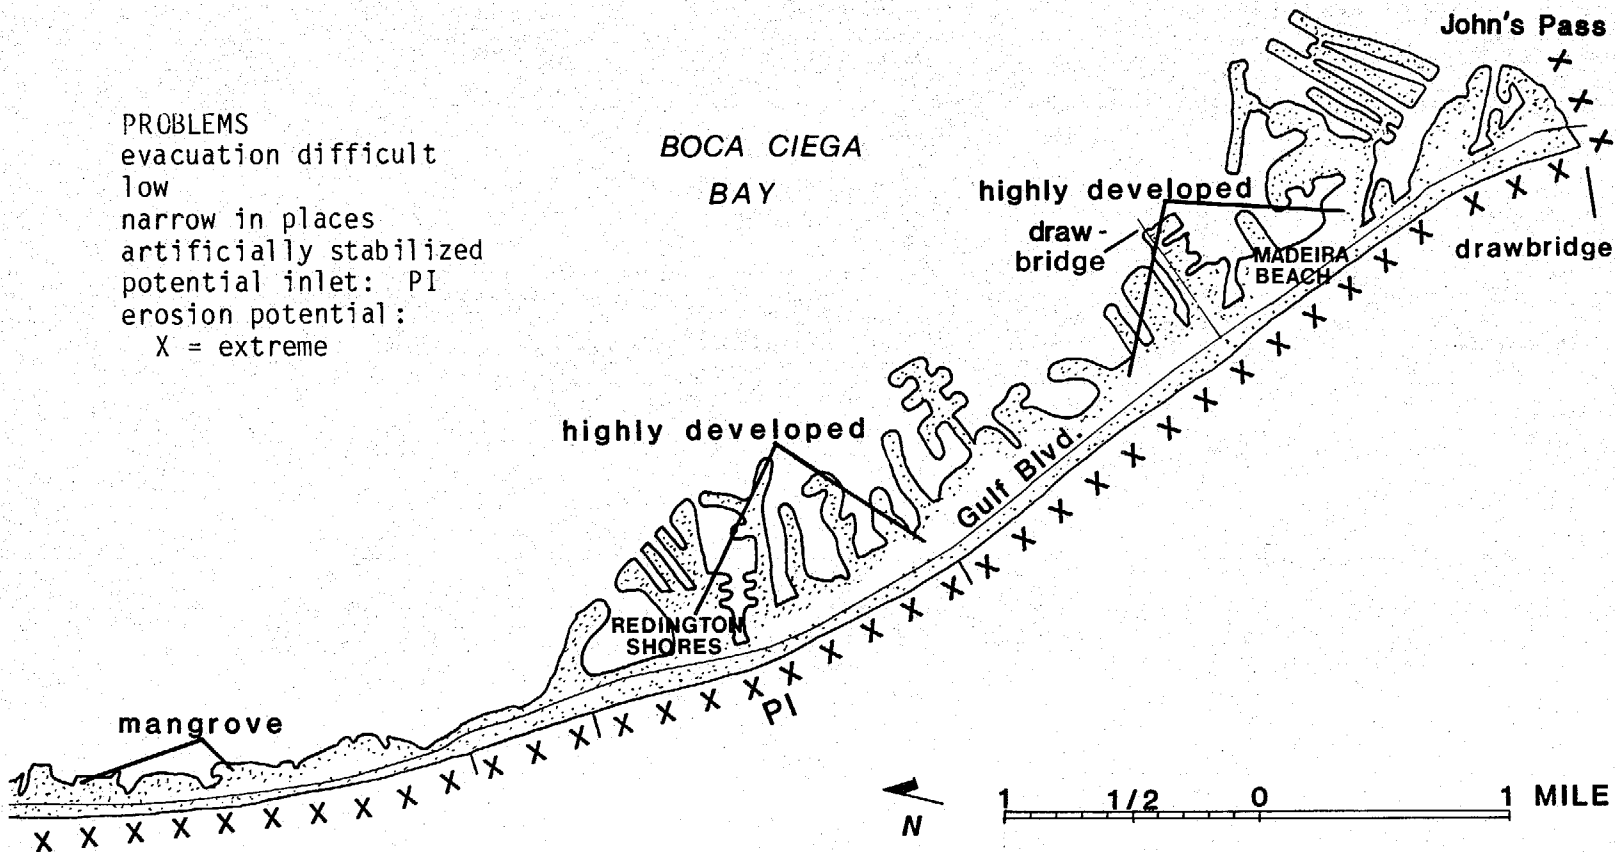
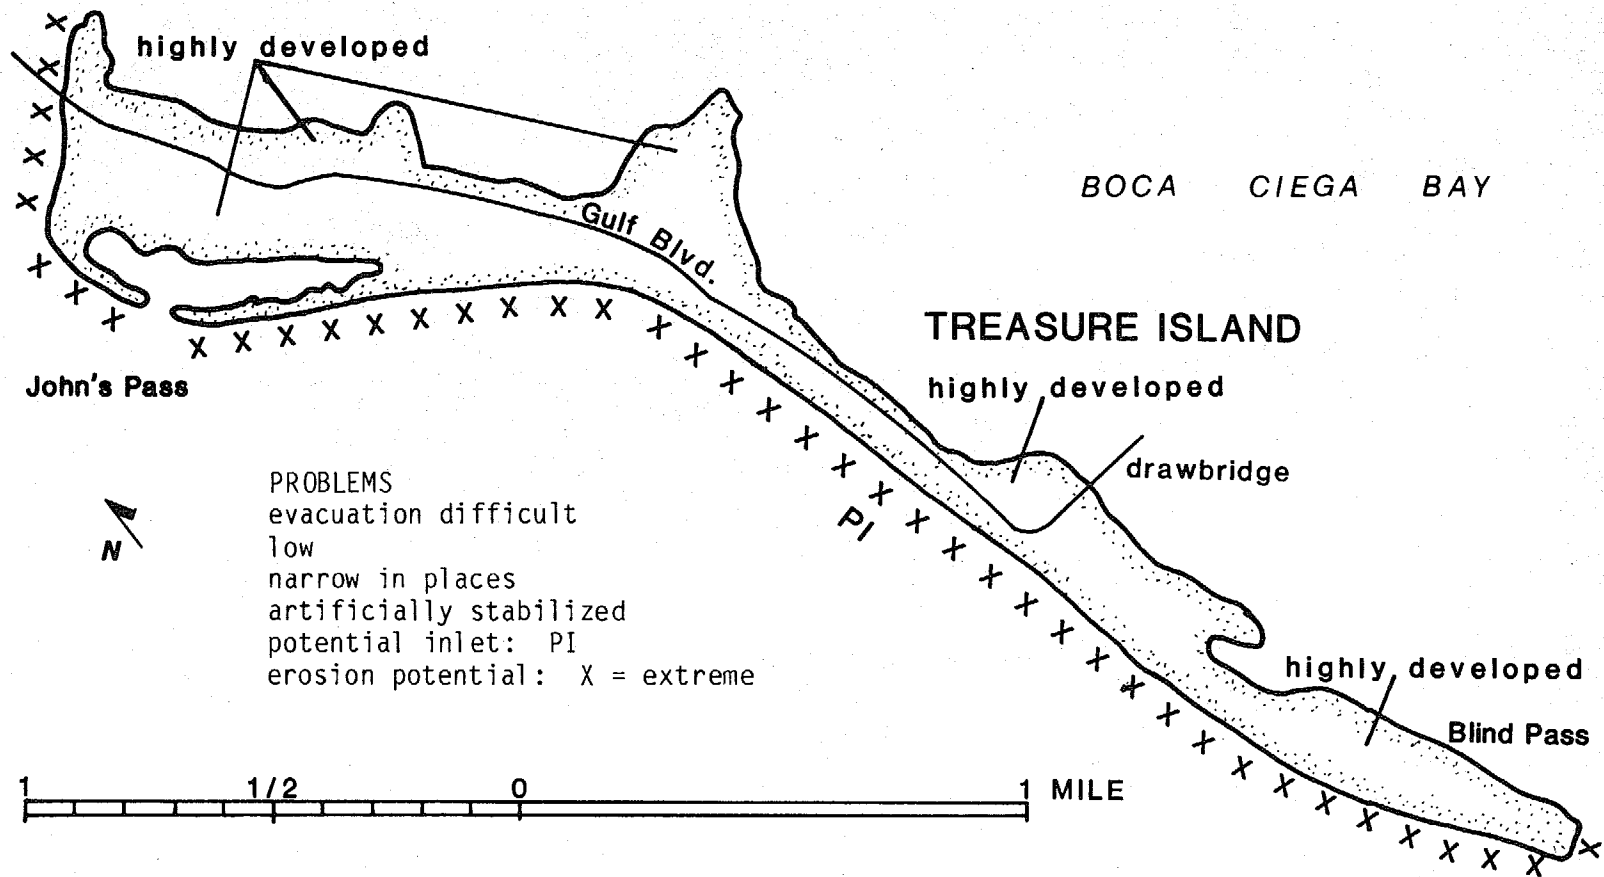
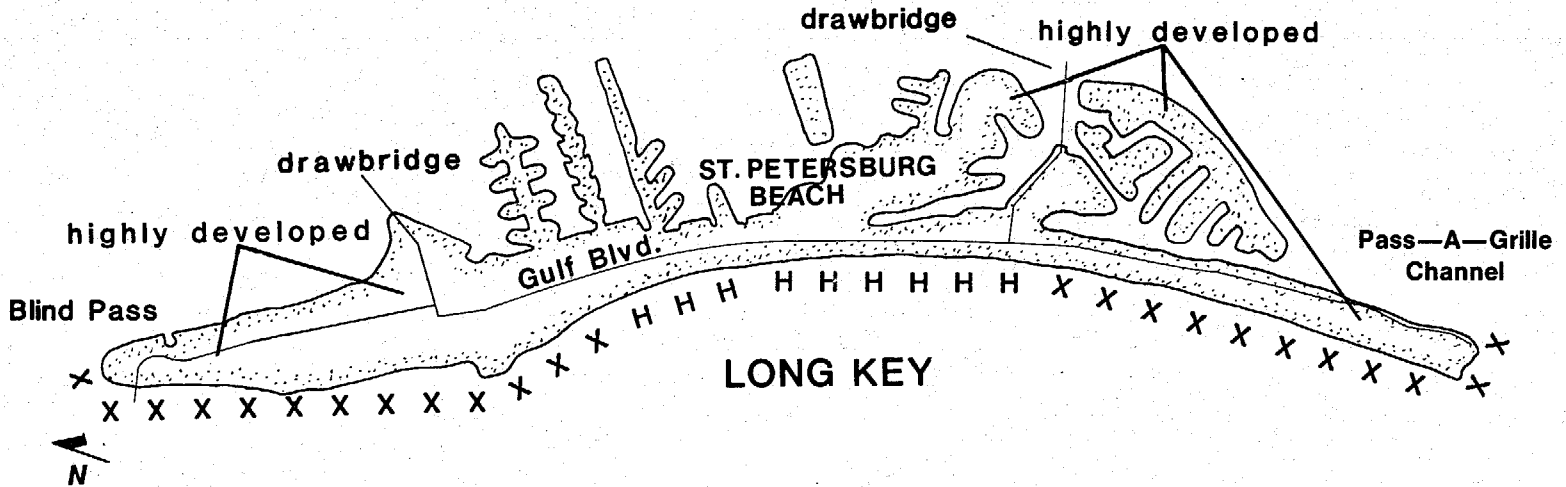
Fig. 5.31. Site analysis map: Treasure Island and Long Key (or John's Pass through Pass-A-Grille Channel).

evacuation difficult low
 artificially stabilized erosion
 potential: H = high
 X = extreme

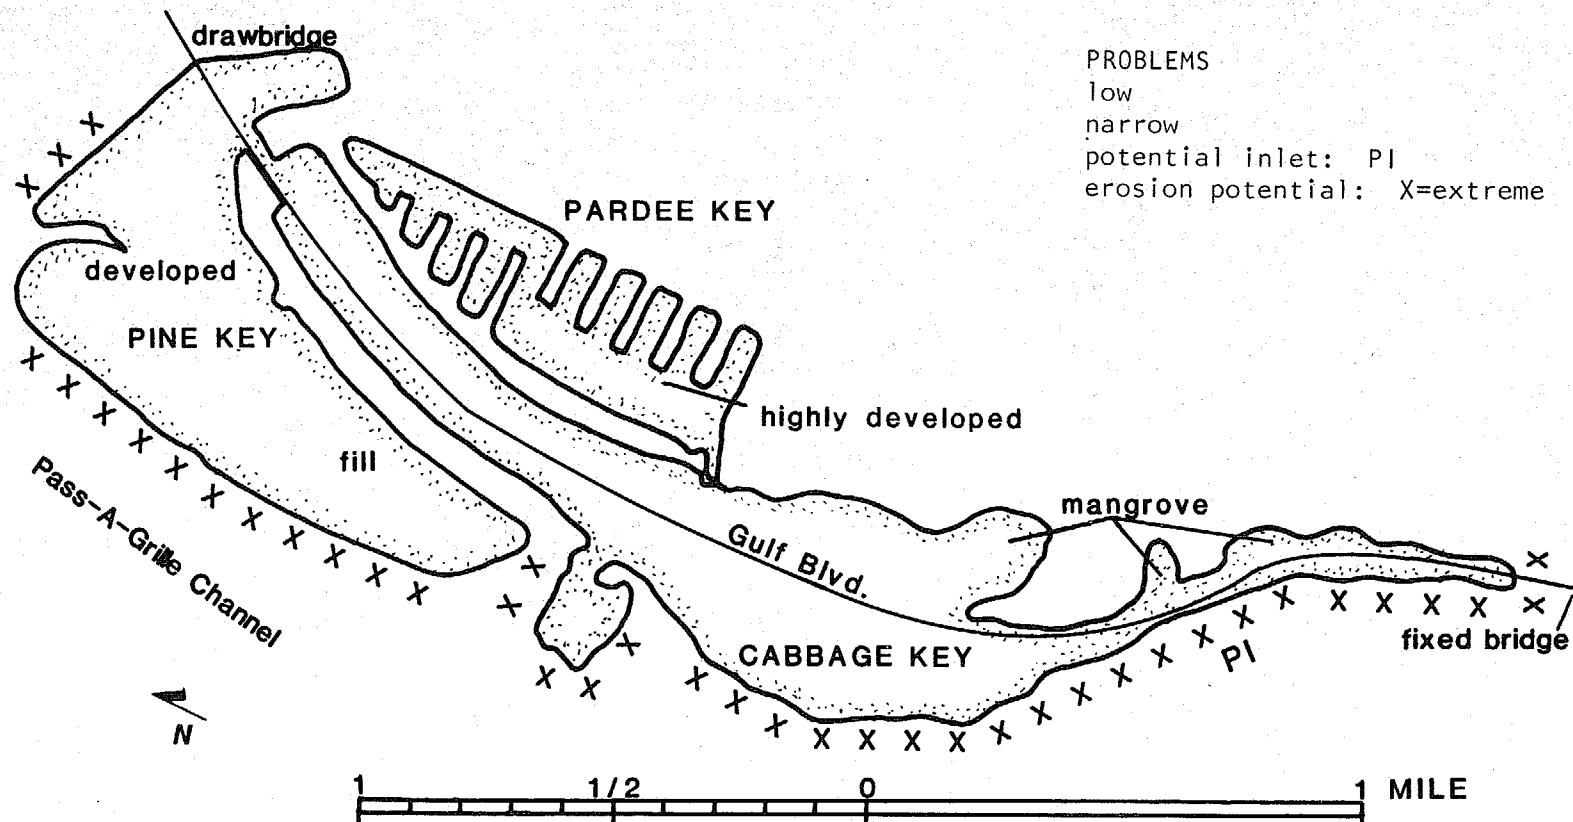
Fig. 5.32. Site analysis map: Pardee Key and Cabbage Key.

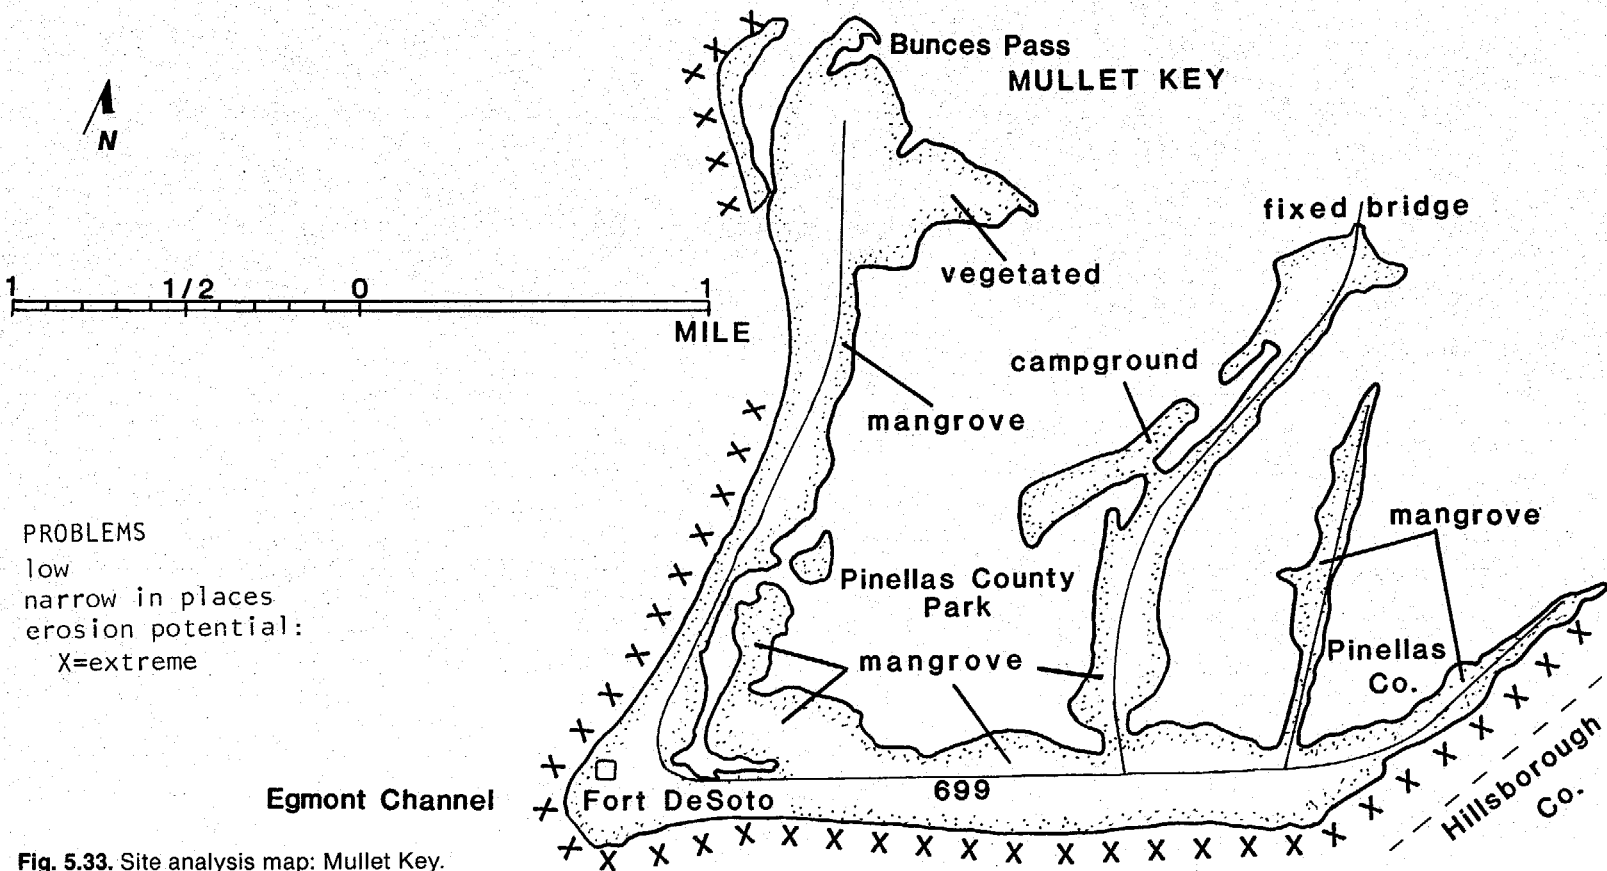
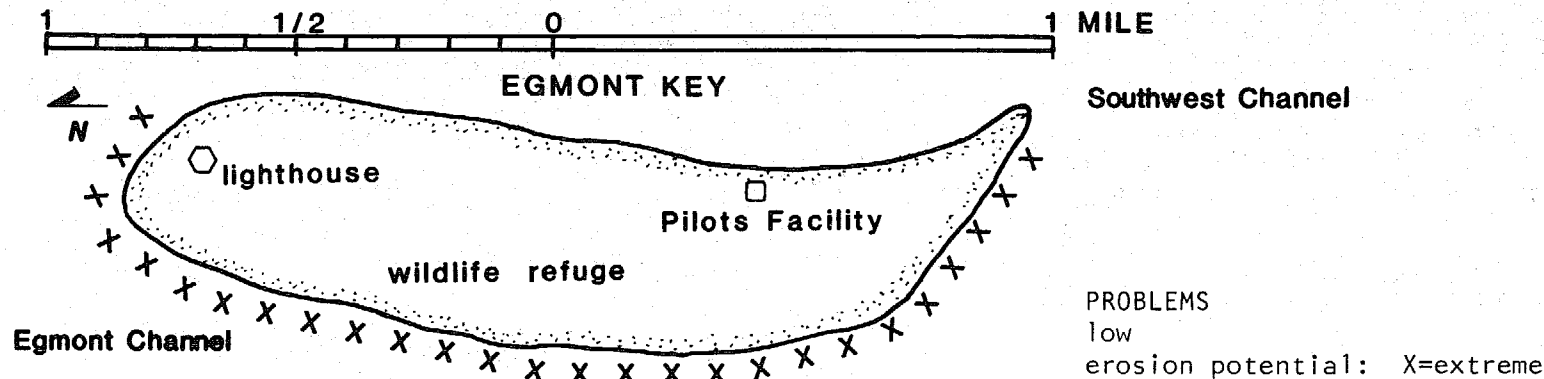
Fig. 5.34. Site analysis map: Egmont Key.

Egmont Key lies squarely in the mouth of Tampa Bay (fig. 5.34). It is relatively undeveloped and is not connected to the mainland. World War II gun emplacements have been undercut by erosion, and the ruins of other facilities of that period remain. A Tampa Harbor Pilot Station is still active, located on the bay side of the island.

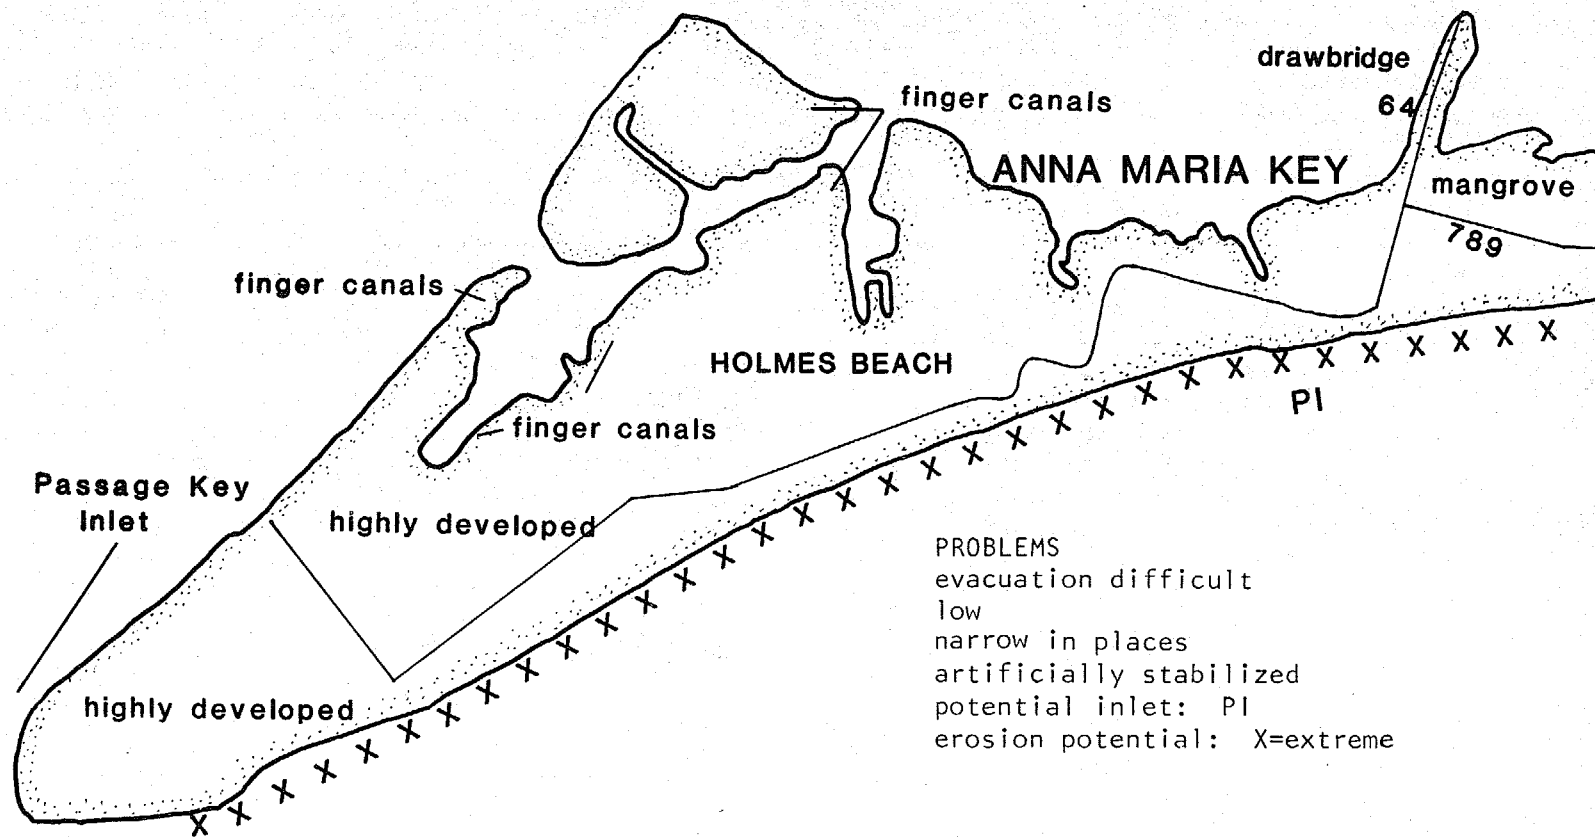
Fig. 5.35. Site analysis map: Anna Maria Key.

The 12 miles of Gulf shoreline in Manatee County consist of 2 low-lying barrier islands, 7.5-mile-long Anna Maria Key (fig. 5.35) and the 4.5-mile northern section of Longboat Key (fig. 5.36). The 2 barrier islands are separated by Longboat Pass. The islands have a northwesterly-southeasterly alignment and vary in width from 400 feet near the southern end of Anna Maria to 1.25 miles near the north end of the same island. The width of Longboat Key varies from 800 feet at the south end to 3,000 feet in the middle section of the Manatee County portion. Elevations of these 2 islands are generally 5 to 9 feet, with the average being about 6 feet.

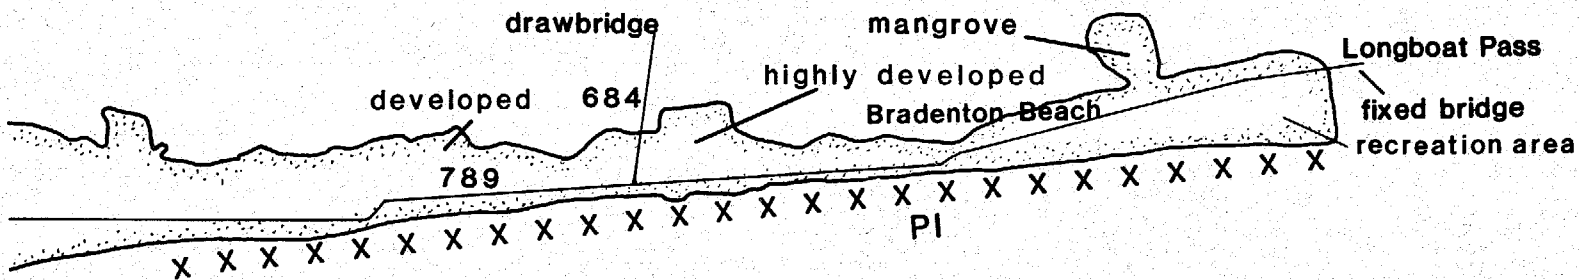
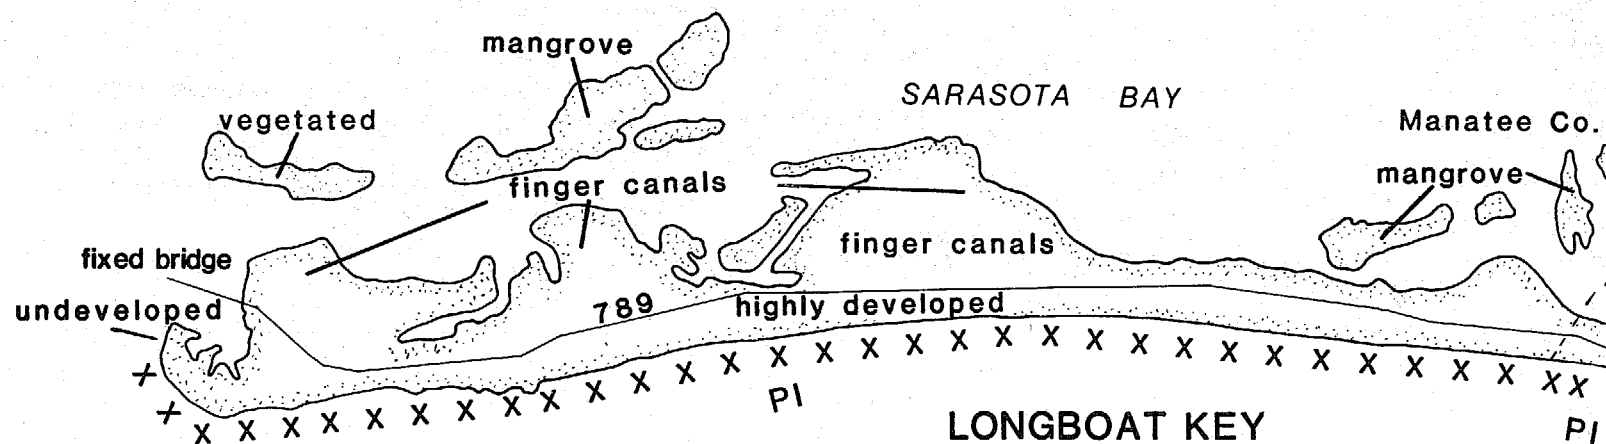
Fig. 5.36. Site analysis map: Longboat Key.

Sarasota County has 35 miles of barrier island beach and encompasses the southern half of Longboat Key. Longboat Key is moderately developed on the Gulf side and has considerable finger canal development on the southern end facing Sarasota Bay (fig.

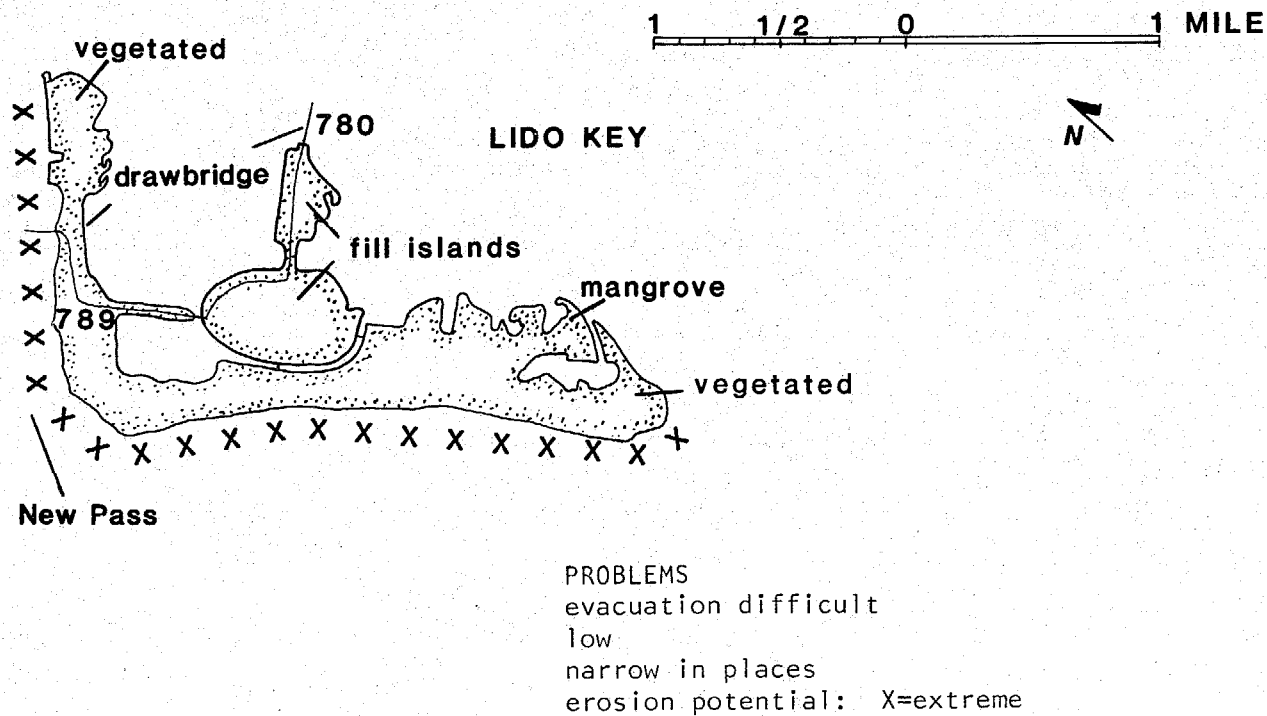
Fig. 5.37. Site analysis map: Lido Key.

5.36). New Pass separates Longboat Key from Lido Key (fig. 5.37), with most development here on the bay side and on St. Armands Key at the end of the long causeway to Sarasota.

Shoreline changes indicate the erosion and buildup trends along the county coastline. From 1883 to 1967 Longboat Key retreated an average of 242 feet. Lido Key shoreline advanced at the north and south ends and retreated in the central section from 1939 to 1967. These changes were influenced by the placement of fill from New Pass dredging. The northern end of Siesta Key built up an average of 602 feet from 1883 to 1967, while the southern half retreated an average of 153 feet during the period from 1883 to 1953. The middle 1-mile section of Siesta Key retreated an average of 108 feet from 1883 to 1967. The northern Casey Key shoreline retreated 225 feet from 1883 to 1939, while the remainder advanced slightly. From 1939 to 1953 Casey Key's entire shoreline retreated an average of 49 feet. This trend continues today. In almost all cases the shoreline stretches at the mouths of inlets have fluctuated back and forth much more than those away from them. In recent years shoreline south of Big Sarasota Pass and north of Midnight Pass have retreated severely, but precise data are lacking.

The offshore 6-, 12-, and 18 foot depth contours generally retreated off Longboat Key, while they advanced and retreated in about equal amounts along Siesta Key. The 6-foot depth contour off Lido Key receded an average of 690 feet along the north end and advanced 596 feet in the southern half during 1883 to 1967.

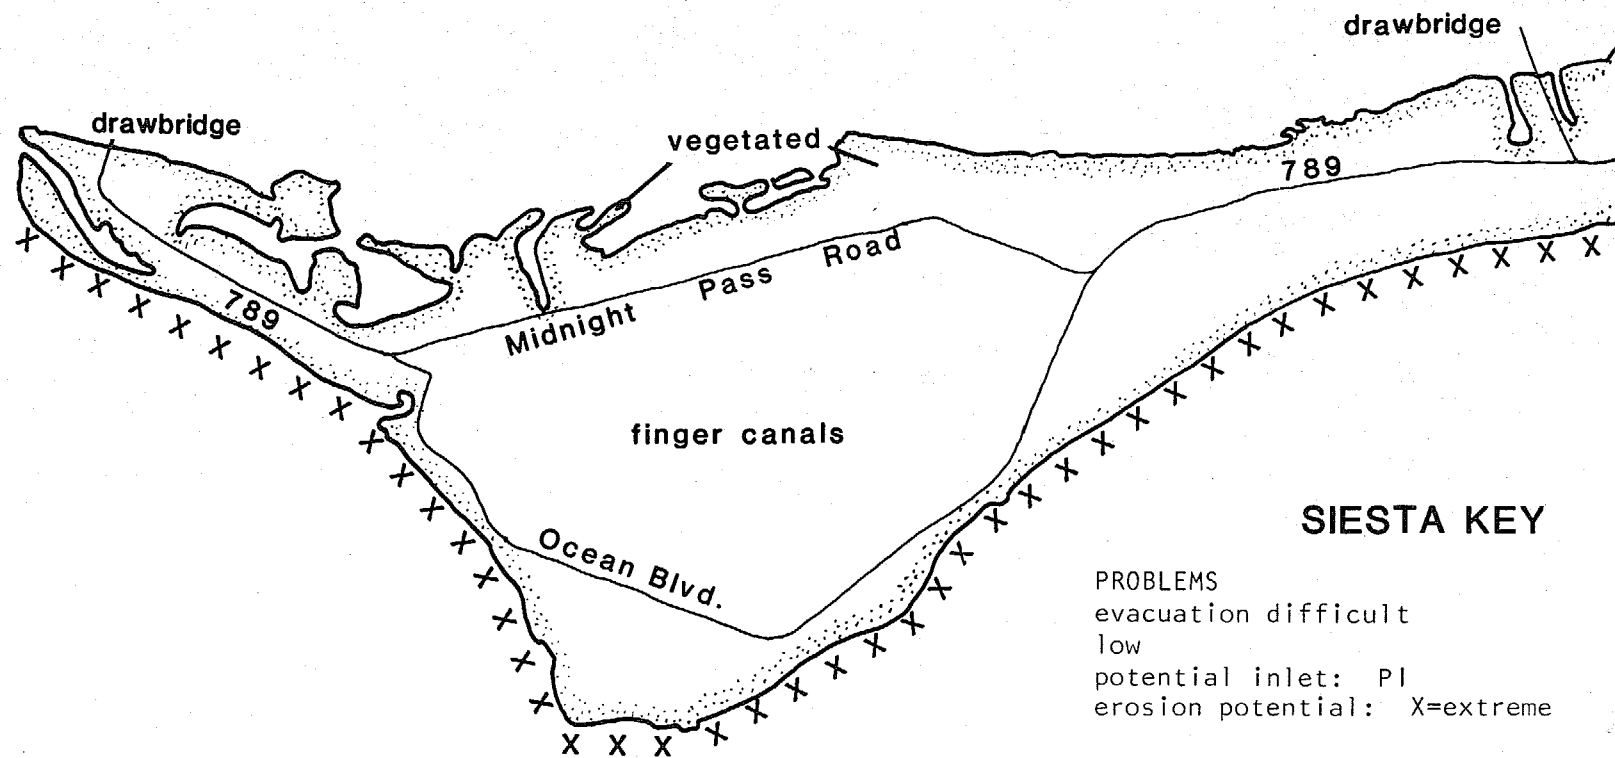
Fig. 5.38. Site analysis map: Siesta Key.
